# **G3 Facsimile Error Code List**

**REVISION 1**

**Canon**  
**HY8-23A0-010**

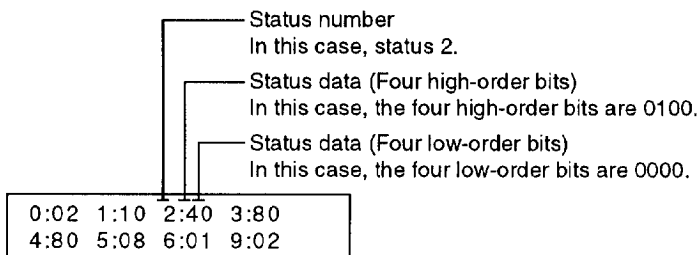
If the four high-order bits of status 2 data are "4", and the four low-order bits are "0", it is converted to a bit pattern of 0100 0000 according to the conversion table below. Only bit 6 is 1.

Bit 6 of status 2 indicates a fixing unit error, so the cause of the printer unit failure is the fixing unit.
